Case Report

Fractures of Cementless Thin-Walled Cups

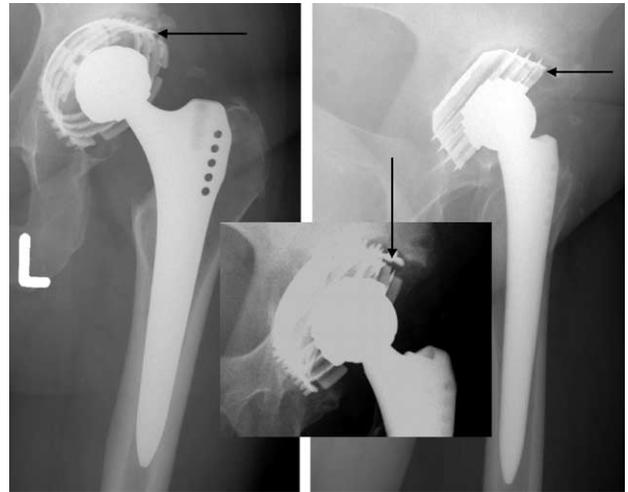
Fig. 3. X-ray 6 years postoperative with a fine fracture line in the cranialateral part of the cup, best seen in the axial view and radiolucent lines in the bone-implant interface in zones I and II.

et al [10]) which had not been visible in previous years. An exact tangential radiograph of the acetabulum revealed a fine hardly noticeable fracture line in the implant (Fig. 3). In June 2001, revision surgery was performed, and it was discovered that the cup had fractured into 3 fragments. There were no signs of impingement at the stem's neck or at the corresponding rim of the metal insert. The insert was intact and not dislocated.

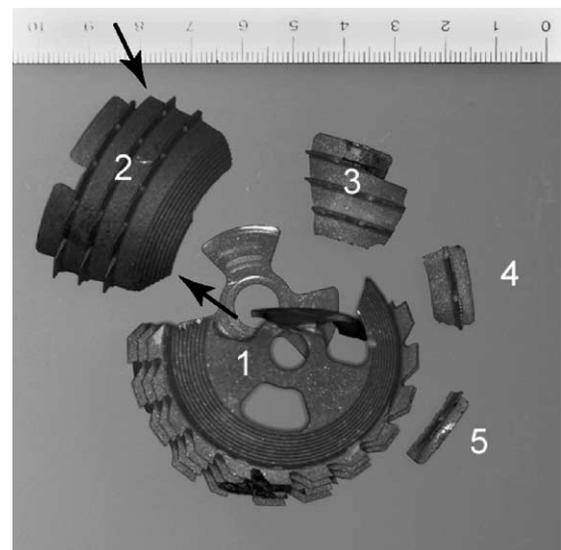
Fig. 4. Macroscopic overview of the cup fractured into 5 fragments. Fragments 1, 2, and 3 due to fatigue, fragments 4 and 5 generated during revision surgery.

Failure analysis of the cup revealed multiple fractures with a hemicircular crack in the polar area and several radial cracks starting at the grooves for the insertion device (Fig. 4). The cup was broken into 5 fragments; however, 2 of these fragments had been created during the revision operation by the extraction of the implant.

no proof of flawed manufacturing or improper implantation. Using SEM, the origin of cracks and the type of fracture (fatigue vs forced rupture) could be analyzed. On fragment 2 (Fig. 4), there were 2 regions where cracks had developed independently of each other (see arrows in Fig. 4). One crack started at 1 of the notches for the insertion instrument (Fig. 5). The other crack began near the polar region from 1 of the 3 holes and later branched out into 2 flaws (Fig. 6).

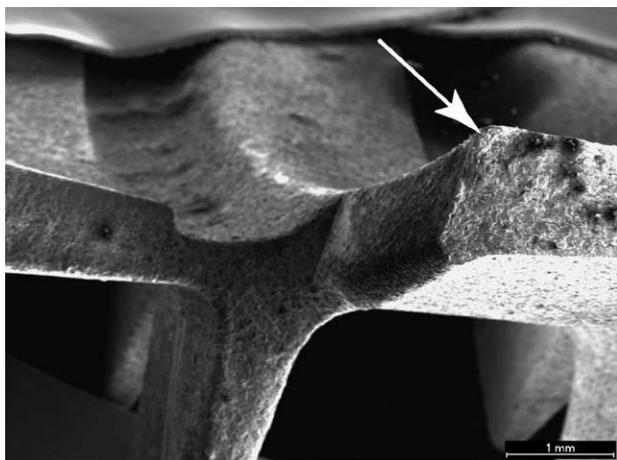
Fig. 5. SEM image (magnification $\times 25$) of fragment 2. The arrow marks the origin of a crack at 1 of the notches for the insertion instrument (region of the upper arrow in Fig. 4).

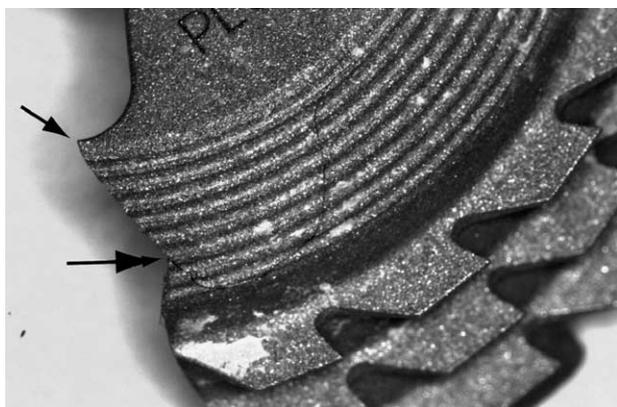
Fig. 6. Macroscopic view of the polar region of fragment 1. Crack origin marked with arrow; later, the crack branched out into 2 flaws (double arrows).

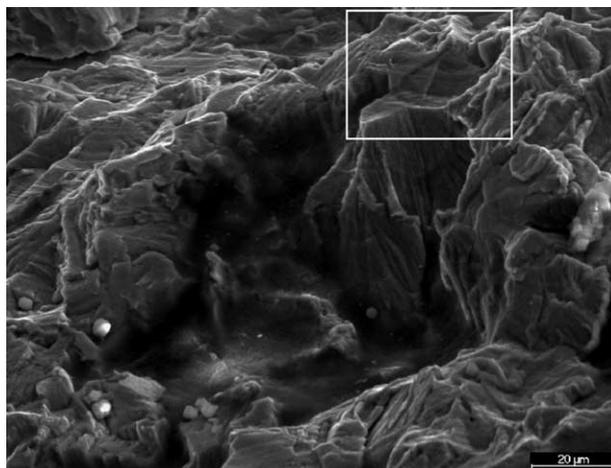
Fig. 7. SEM image (magnification $\times 800$) of the fracture surface at the polar region of fragment 2 (lower arrow in Fig. 4).

The fact that there were multiple origins for the cracks proves that the implant was generally overloaded. All cracks developed sequentially. A forced rupture due to the patient's traumatic fall could be excluded as the cause by the presence of so-called striations. Fig. 7 displays the fracture surface of fragment 2 at the polar region. At high magnification, the striations, which are typical of fatigue failure, are recognizable (Fig. 8).

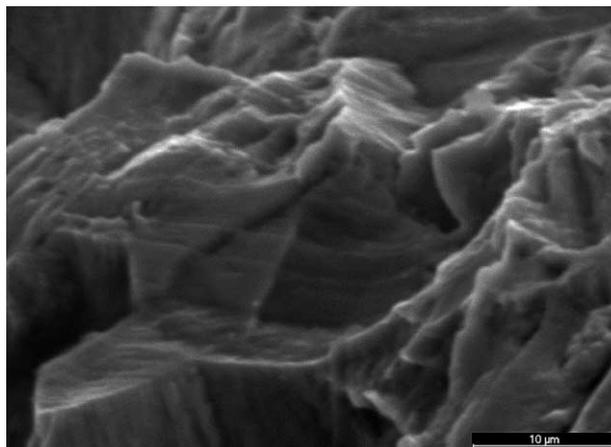
Fig. 8. SEM detail of Fig. 6 (magnification $\times 3000$) showing fracture surface with striations (marked rectangle in Fig. 6).
