Case Report

Fractures of Cementless Thin-Walled Cups

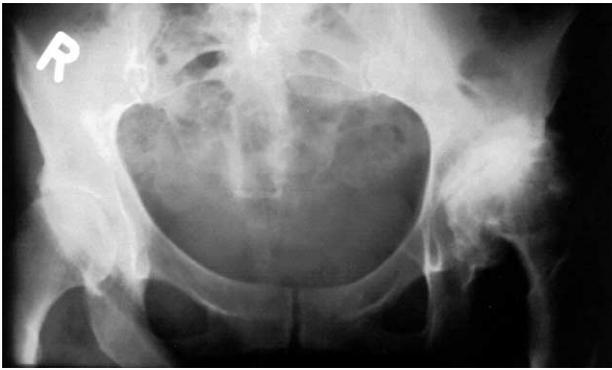
Fig. 1. Preoperative radiograph with dysplastic coxarthrosis type 2 according to Crowe on the left side.

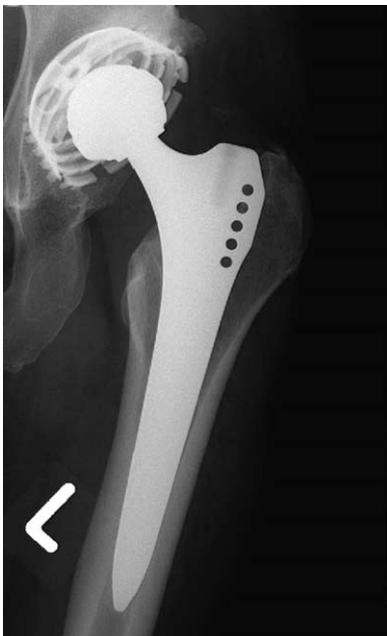
A Bicon cup (Plus Endoprothetik AG) with the following measurements was implanted: size 5 (outer diameter 56, inner diameter 53, wall thickness 1.5 mm), a Sikomet metal-on-metal bearing (sandwich liner with polyethylene between the cup and the metallic bearing part) (Sikov Medizintechnik GmbH, Vienna, Austria), and an “SL” straight tapered stem (Fig. 2).

Fig. 2. Total hip arthroplasty 3 days postoperative.
